Maidenhead
Civic Society

York Stream

A review of past efforts to keep the stream clear

January 2006

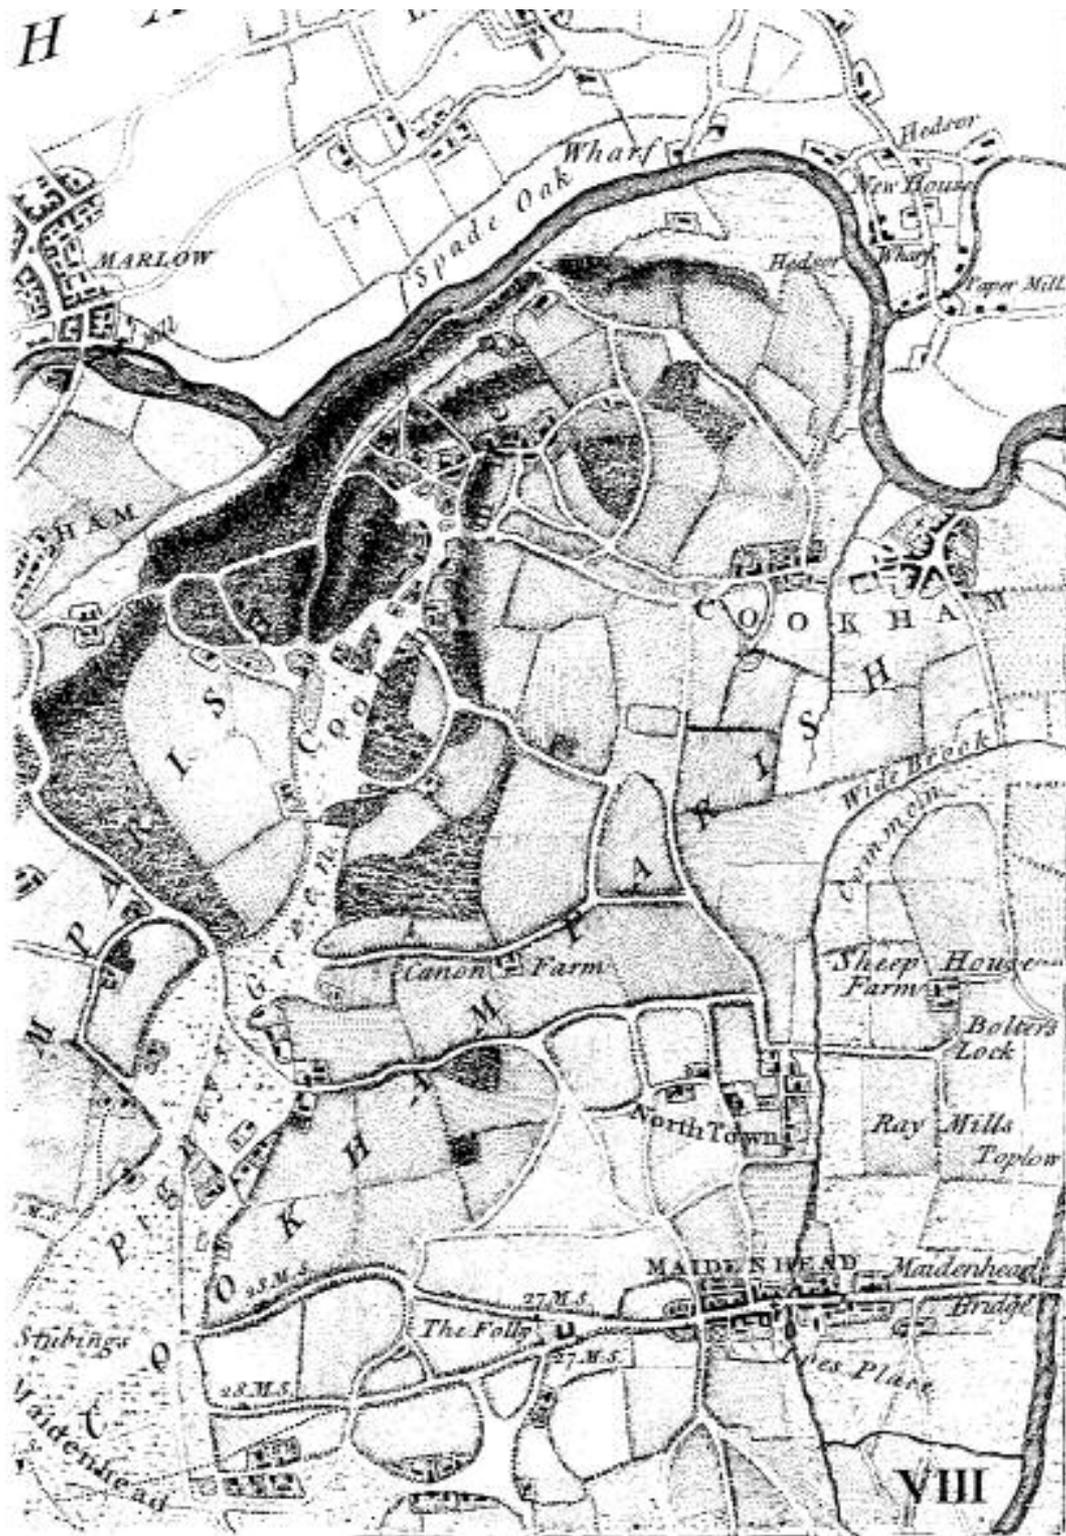
Map 1: Rocque's map, 1761

Map1: Rocque's map of 1761 shows that the White Brook (then called the Wide Brook) apparently was not connected to the stream at Cookham. It is not clear which way the Cookham stream flowed. By 1804-ca1813 (see Map 2) the stream bisecting Marsh Meadow seems to have disappeared to be replaced by ditches along the edge of the meadow⁴. The flow of the White Brook is also unclear but if this map is accurate⁵, was presumably from the Thames flowing westwards.

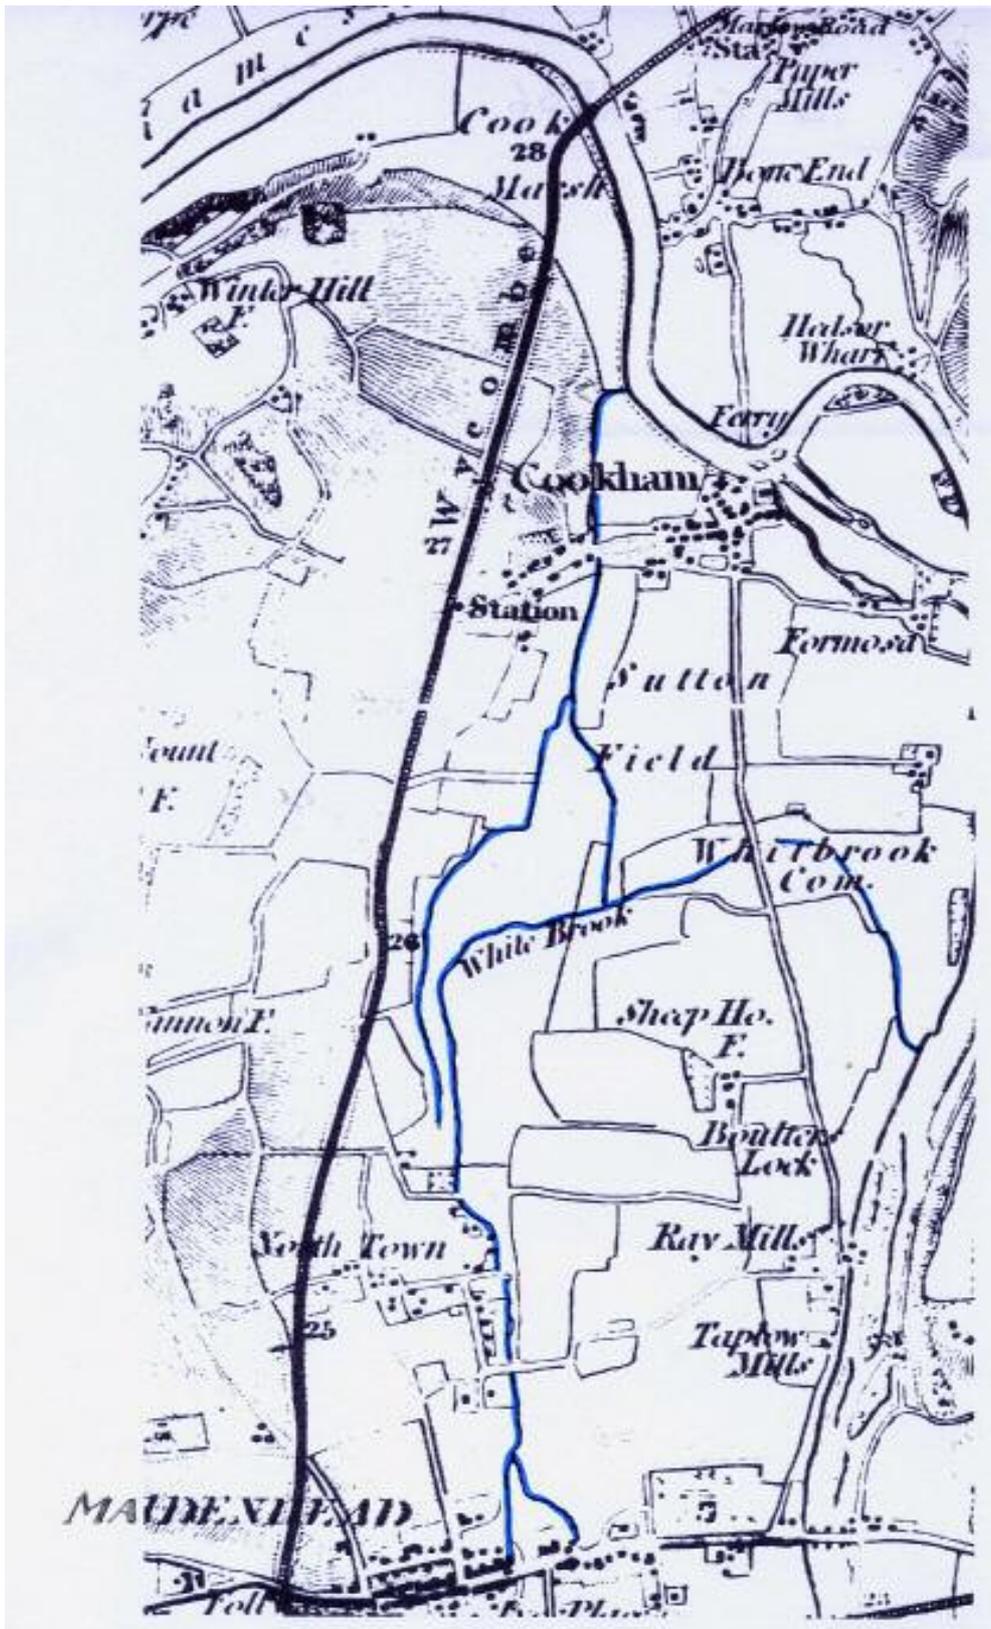
Map 2: Stream system (in blue) ca 1813

Map 2: First edition of the 1-inch to one mile Ordnance Survey maps surveyed between 1804 and ca 1813, shows a connection between the stream from Cookham and the White Brook⁶. At that point two streams appear to flow towards Maidenhead, though only the one that connected with the White Brook reached the town. The other, presumably the precursor of Maidenhead Ditch, ceased flowing north of North Town Moor. At this time Strandwater apparently did not yet exist⁷.

⁷ Interestingly Widbrook Common appears to have been much larger in those days (compare Map 2 with Map 3).

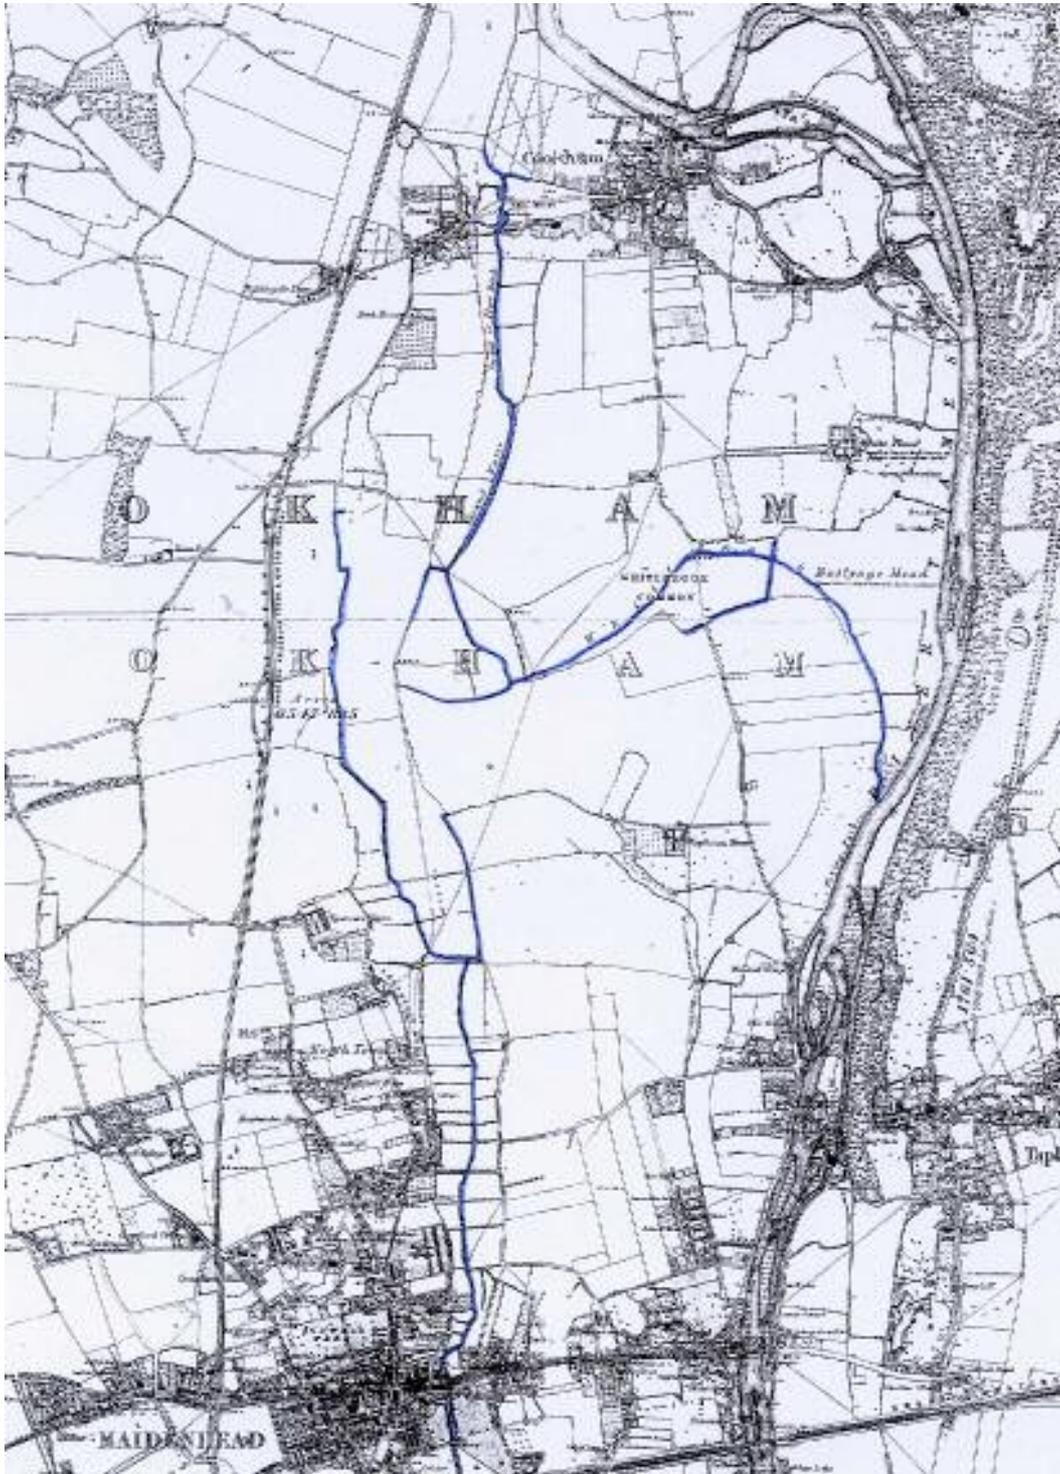
Map 3: Stream system ca 1875

Map 3: First edition of 6 inch to 1 mile O.S map surveyed in 1875⁸ shows ponds at Cookham, the creation of Strandwater and the alteration of the stream system - changes which seem to have affected the flow of the White Brook. Strandwater connected with the White Brook but not with Maidenhead Ditch (see Map 4). The predominant flow in 1875 from Strandwater was almost certainly eastwards towards the Thames; flow is not indicated in this map but the White Brook is shown flowing eastwards in the 1914 O.S. edition. Although not clear from Map 3⁹ there appears to have also been some flow towards Maidenhead. In 1888 dams which had been placed in Strandwater by the local land owner were dismantled by main force because they were held to be causing lack of water on Widbrook Common and had also affected Maidenhead Moor where it was reported that “the water here was almost stagnant and was in a filthy state”.¹⁰ Later still, in 1924/25, York Stream (then called the Canal Stream) is described as having its source in the Strandwater near Cookham and flowing in a southerly direction right through the Borough subsequently joining the river below Bray Lock and being the only natural watercourse with running water in the Borough.¹¹

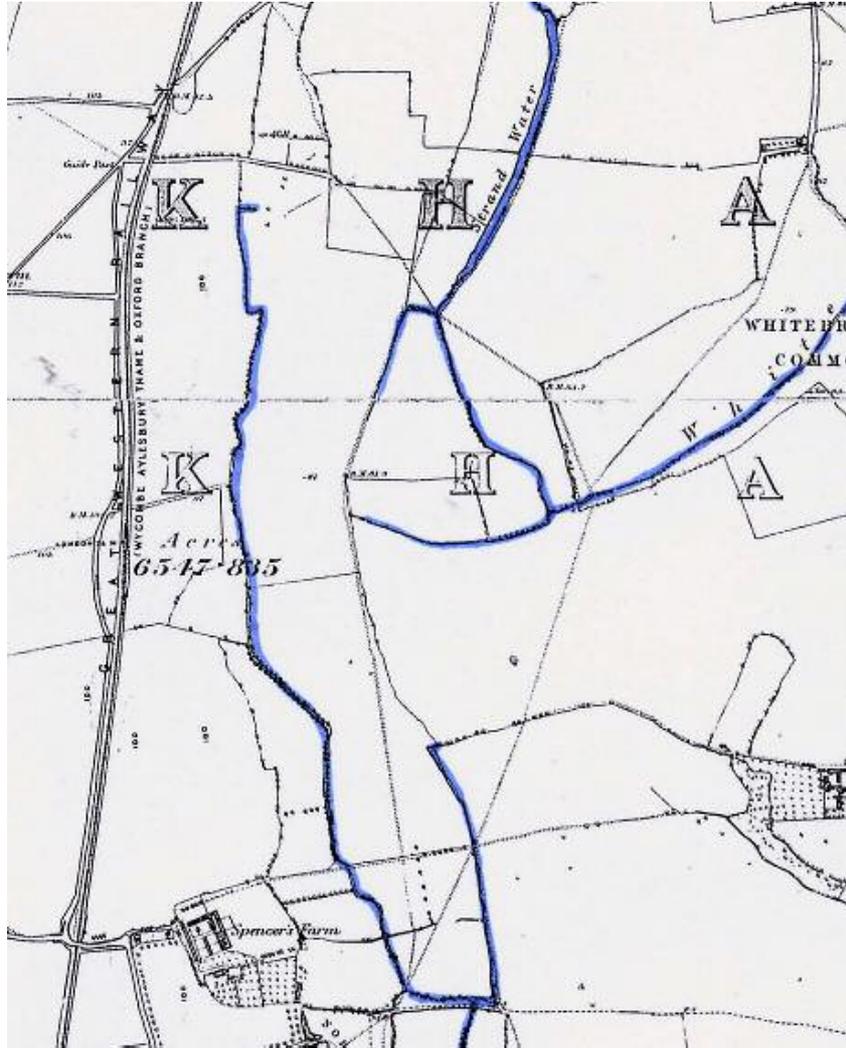
Map 4: Enlargement from Map 3

Map 4: Close-up of Map 3 showing the lack of connection between Maidenhead Ditch and the White Brook.

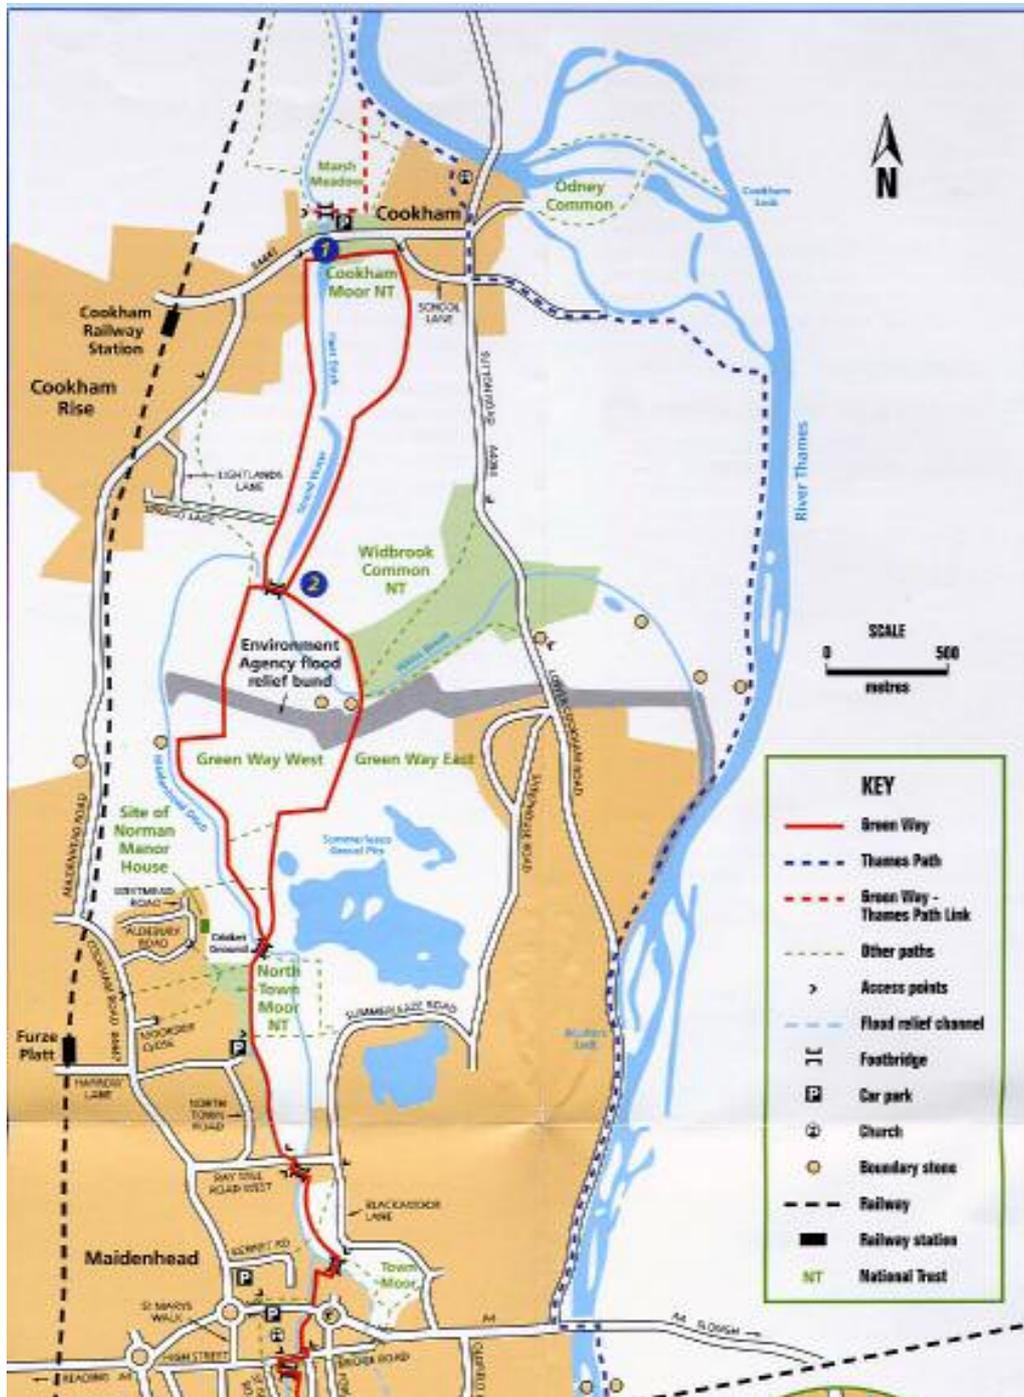
Map 5: Section of the Green Way map

Map 5: The Green Way map showing the current stream system. If Map 5 is compared with Map 3 it will be seen that part of the White Brook has disappeared¹². It was only in 1948¹³ that a connection from the Strandwater/White Brook system was made with the Maidenhead Ditch creating a single stream. This very awkward connection is now completely clogged with reeds, as is most of the Ditch. It seems that since 1948 the White Brook has reversed direction and flows mostly westwards towards Maidenhead except during flood conditions when it definitely flows eastwards to the Thames.

¹² The dry streambed is close to the flood bund which actually crosses it. This dry bed is still marked as a stream on recent O.S. Explorer maps.

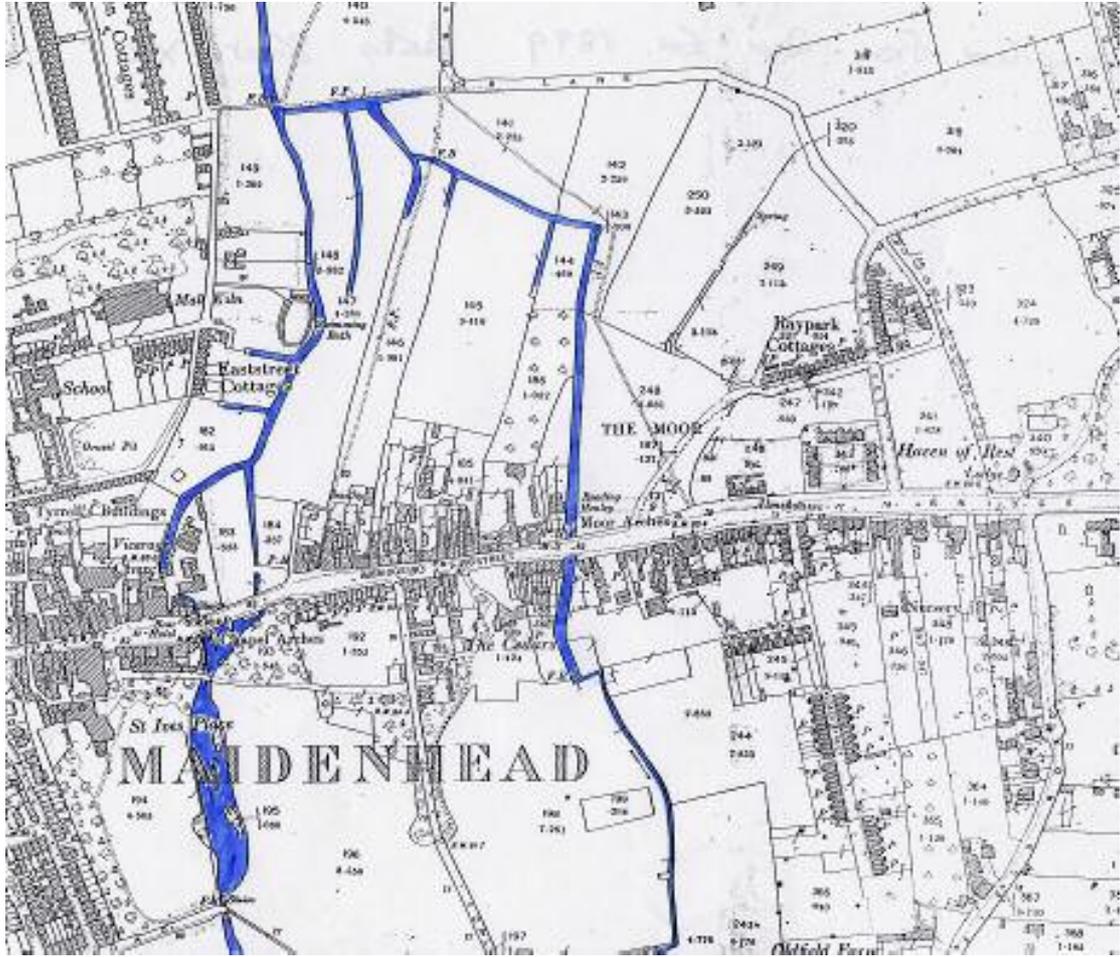
Map 6: Stream system on Maidenhead Moor ca 1899

Map 6: Compiled from adjacent sheets of the second edition (1899) of the 25 inch to one mile O.S. maps of Maidenhead, showing the stream system before the 1920s when, due to the

widening of Chapel Arches, the greater part of water flow was directed down the current channel rather than that next to the Bear Hotel¹⁴.

²¹ This stream no longer exists. For location see Map 6.

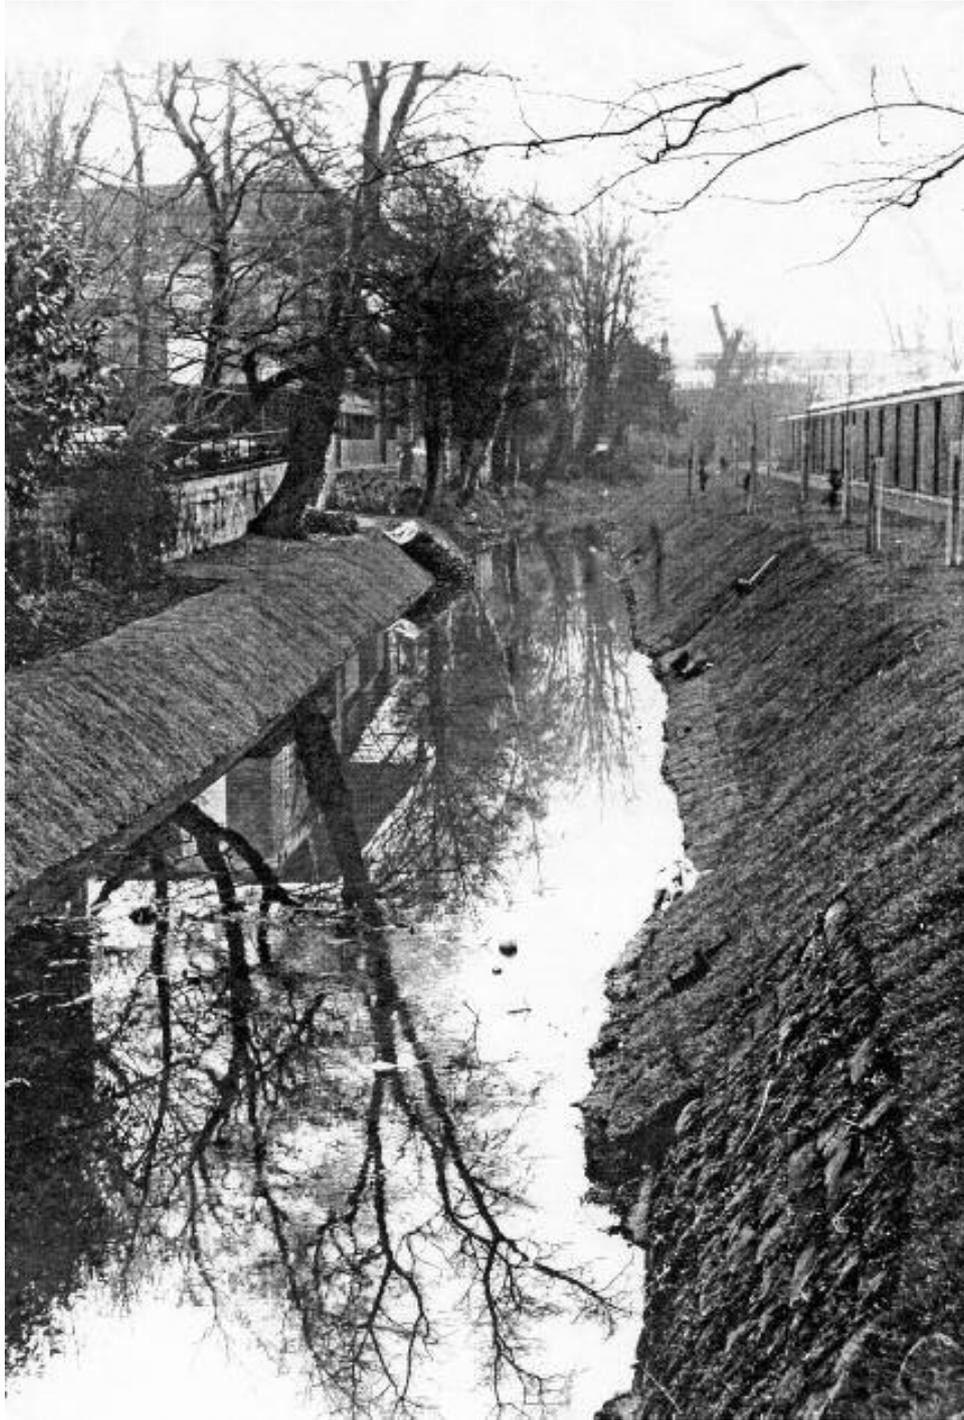
Photo 1: York Stream in January 1973, after clearing

1973: The town centre section of York Stream was cleared of rubbish, the banks grassed and trees planted by the Borough Surveyor and the Parks Committee as part of the new library project (Photo 1²²).

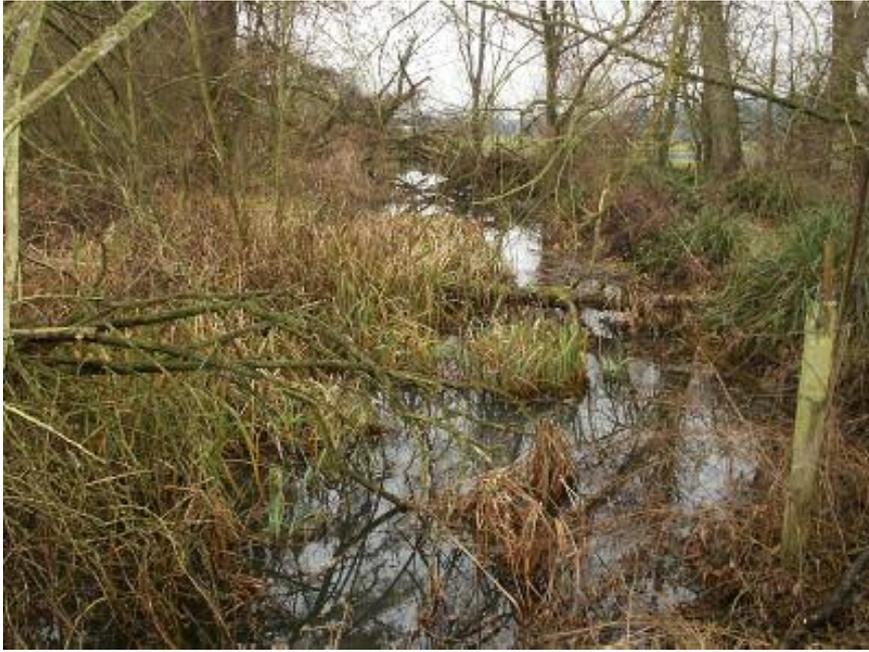
**Photo 2: The White Brook (near to its junction with the Thames)
before tree clearance, January 2004**

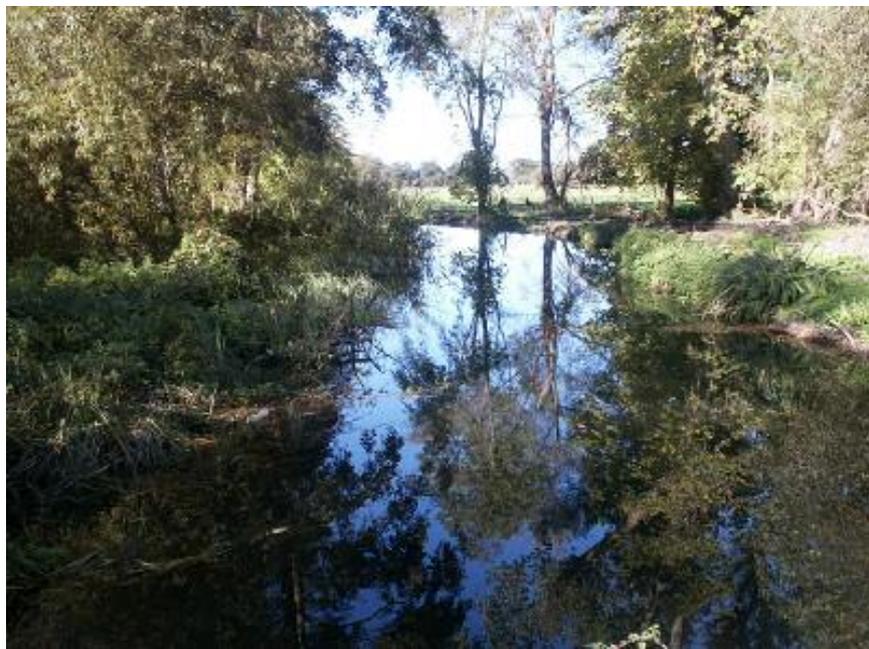
**Photo 3: The White Brook after tree clearance and dredging,
October 2004**

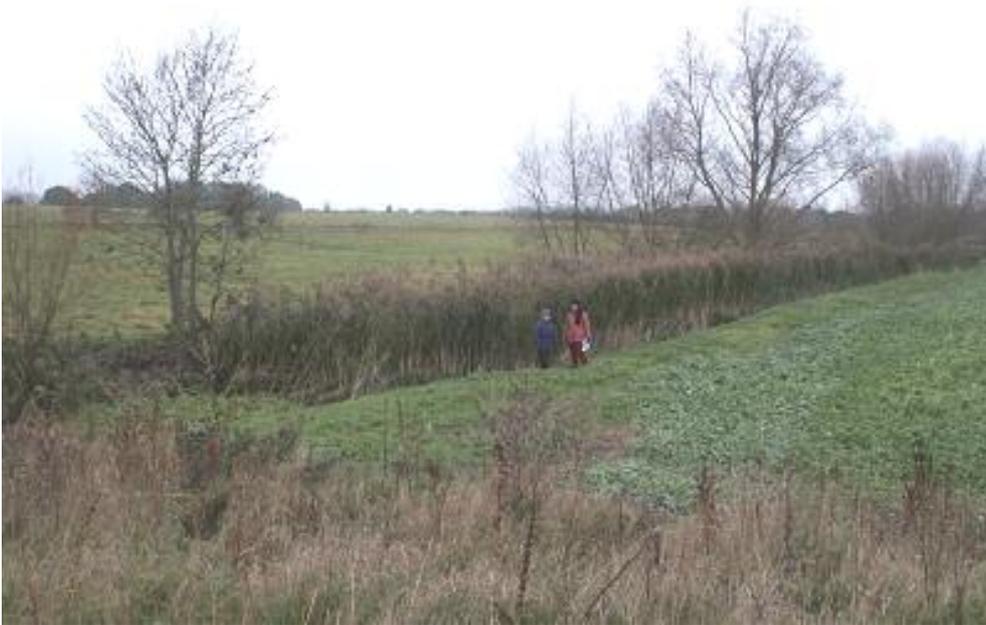
Photo 4: Reeds in Maidenhead Ditch north of the Flood Control Gate, November 2005

¹⁶ The wide channel causes the water to slow and drop its silt providing the ideal habitat for reed growth. One method used to narrow watercourses is marginal shelving. See NRA magazine *Newscast*, summer 1992 p 5.

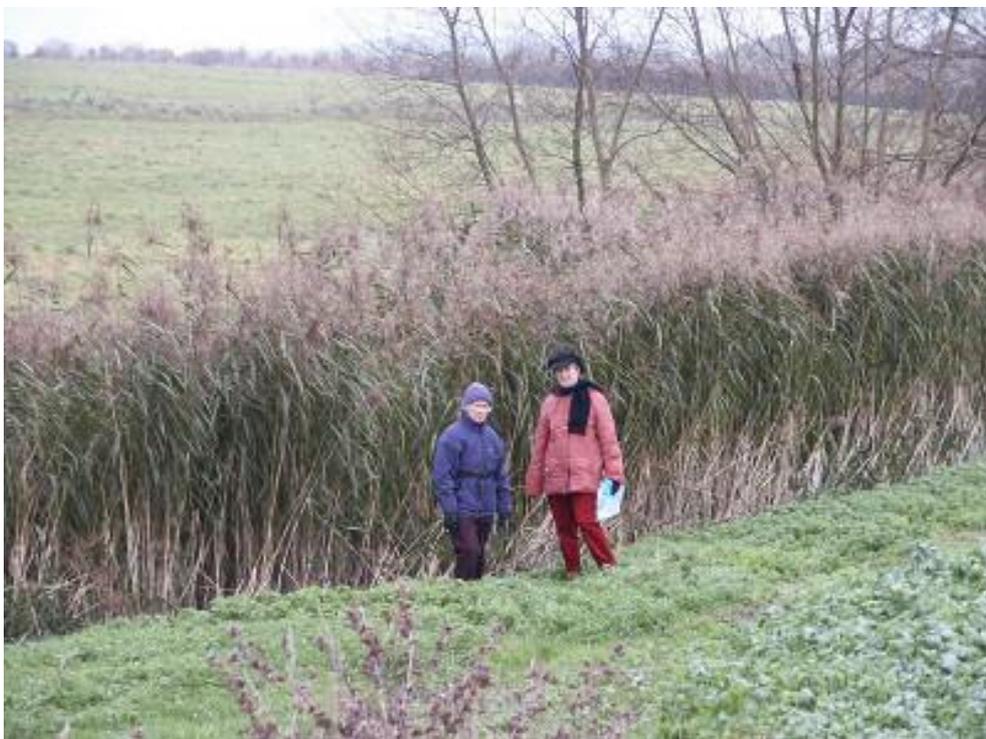
Photo 5: Close up of reeds

Photos 4 and 5 shows reeds in Maidenhead Ditch north of the flood control gate i.e. in the awkward connection mentioned above, whilst Photos 6 and 7 show a section of the Ditch diverted to increase space at the cricket club. The latter photos show the amount of reeds and watercress that has accumulated in this newly created stream from 1998 to 2005.

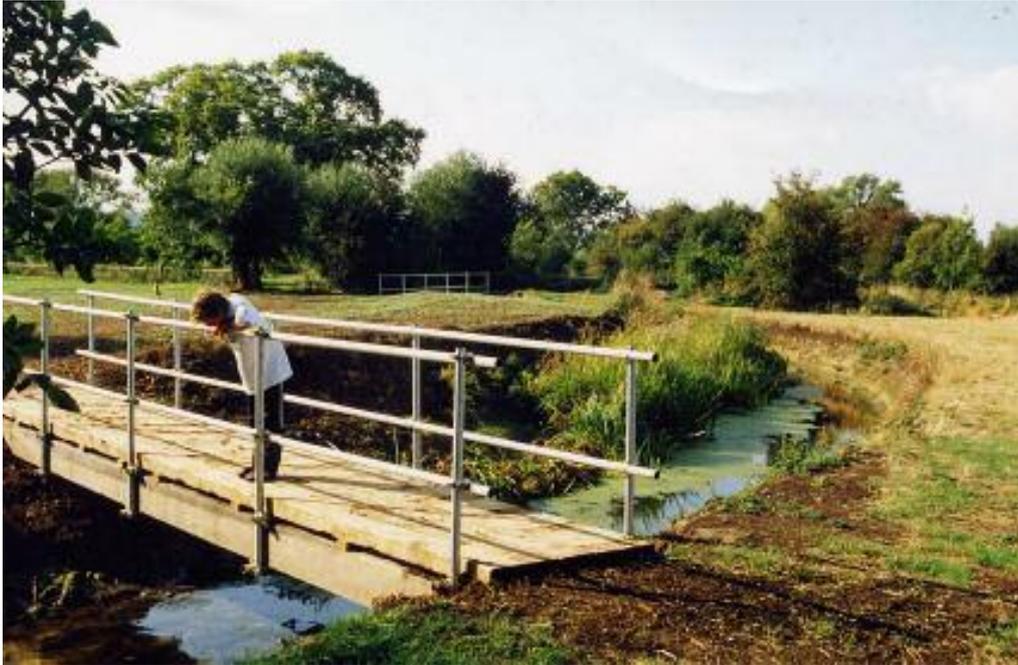
Photo 6: Newly diverted Maidenhead Ditch near to the cricket club, September 1998

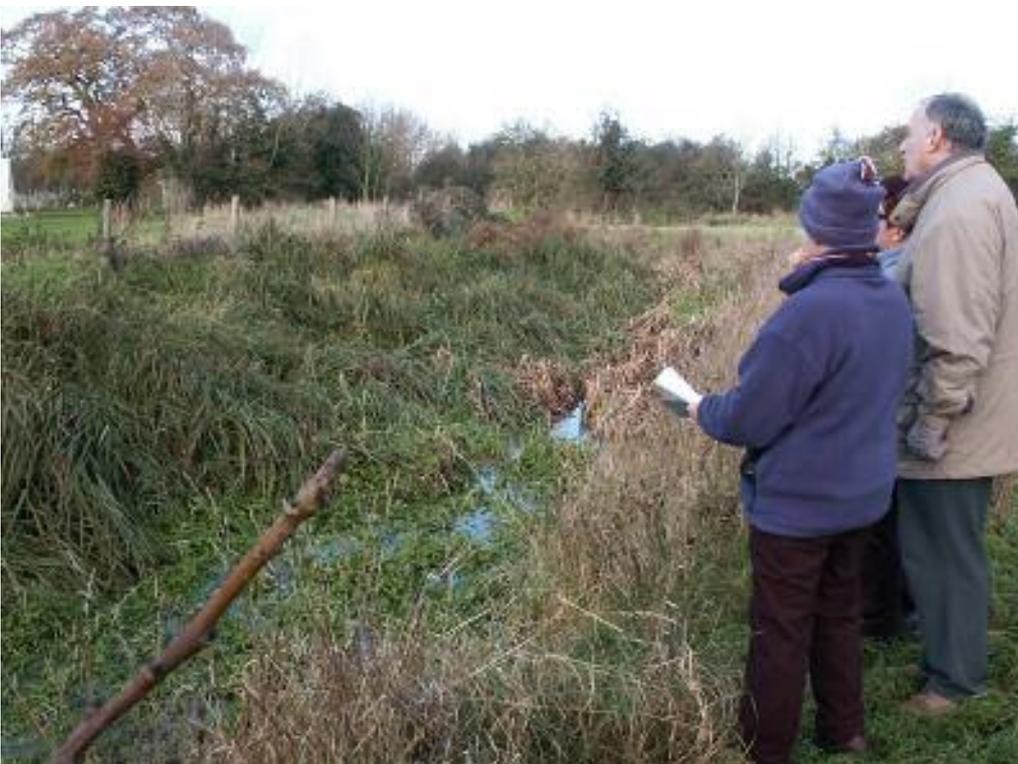
Photo 7: Same section of Maidenhead Ditch, November 2005

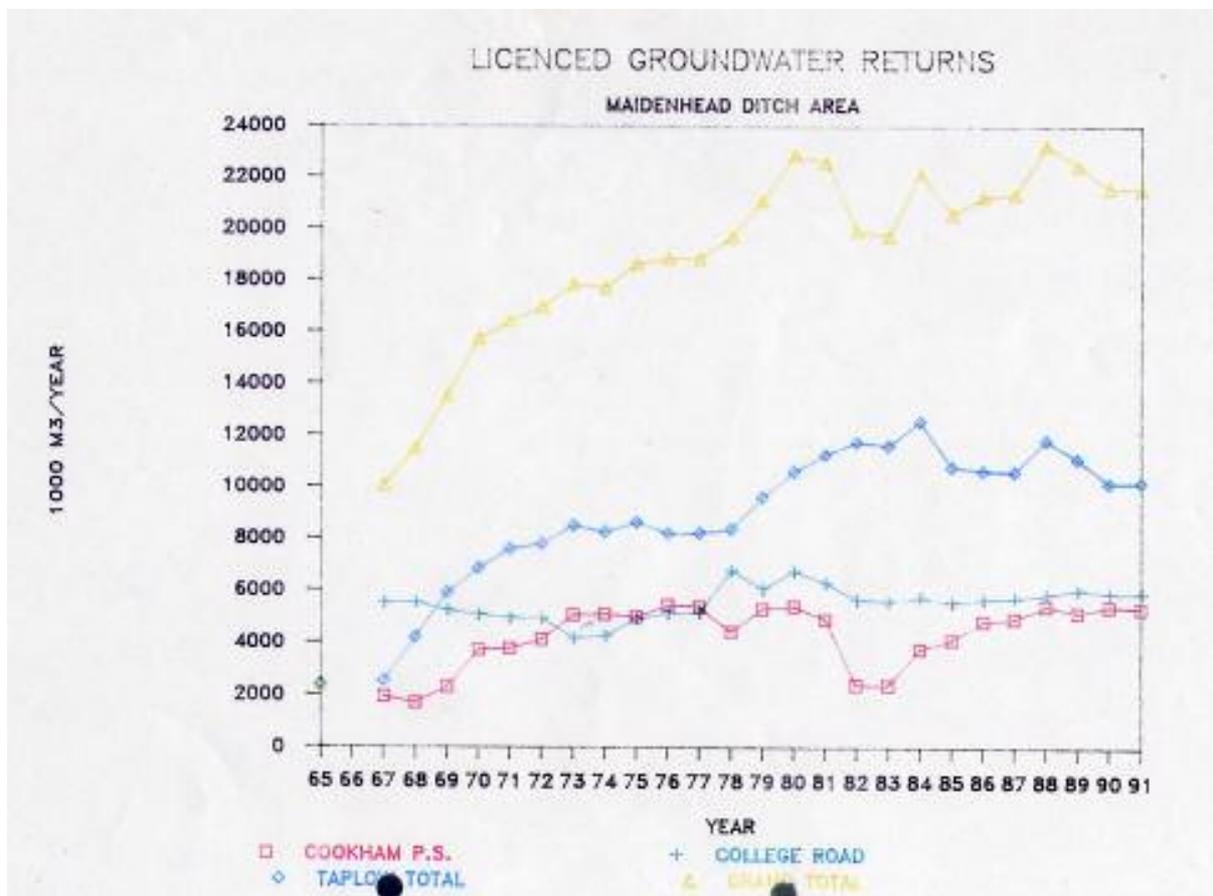
Graph 1: Groundwater abstraction in Maidenhead area 1967-91
